INVESTIGATION REPORT

Company Name: California Western Railroad (Skunk Train)

Date of Investigation: September 23, 1998

Investigation Report
California Western Railroad – Skunk Train
September 23, 1998

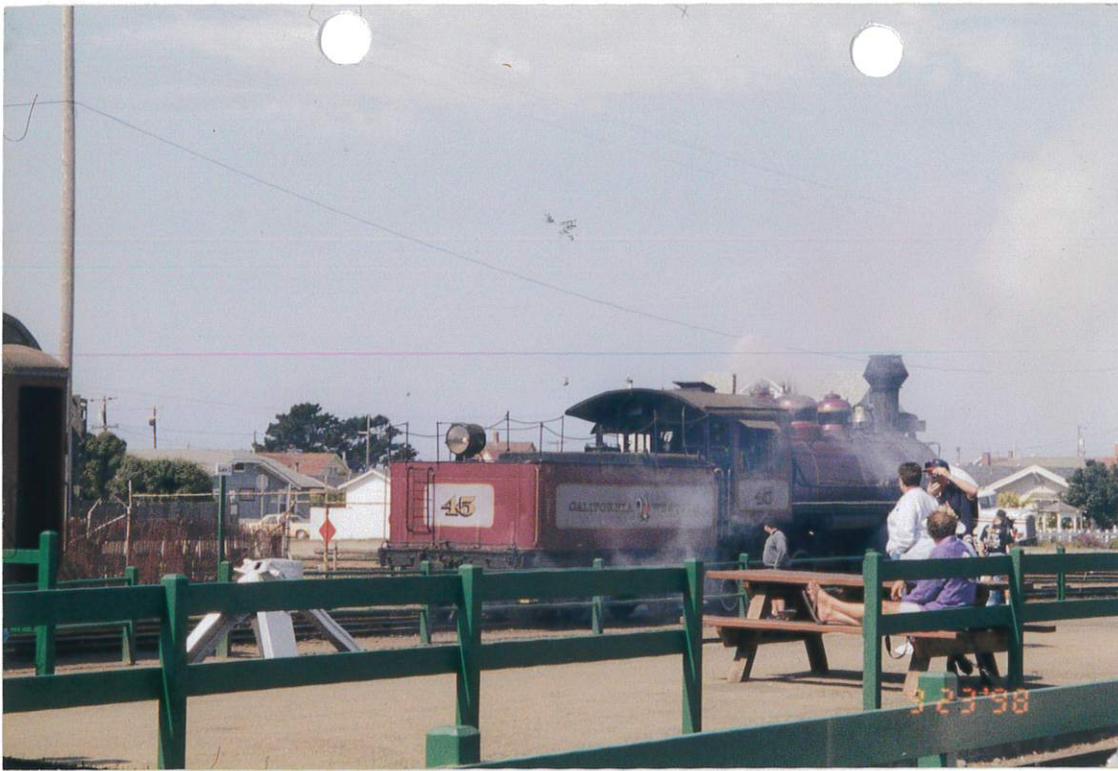
1. Locomotive #45 (steam engine) currently burning used/recycled oil as a fuel.

Locomotive #45 arrived (Attachment A, photo #1) at the same time as we did. When we entered the ticket

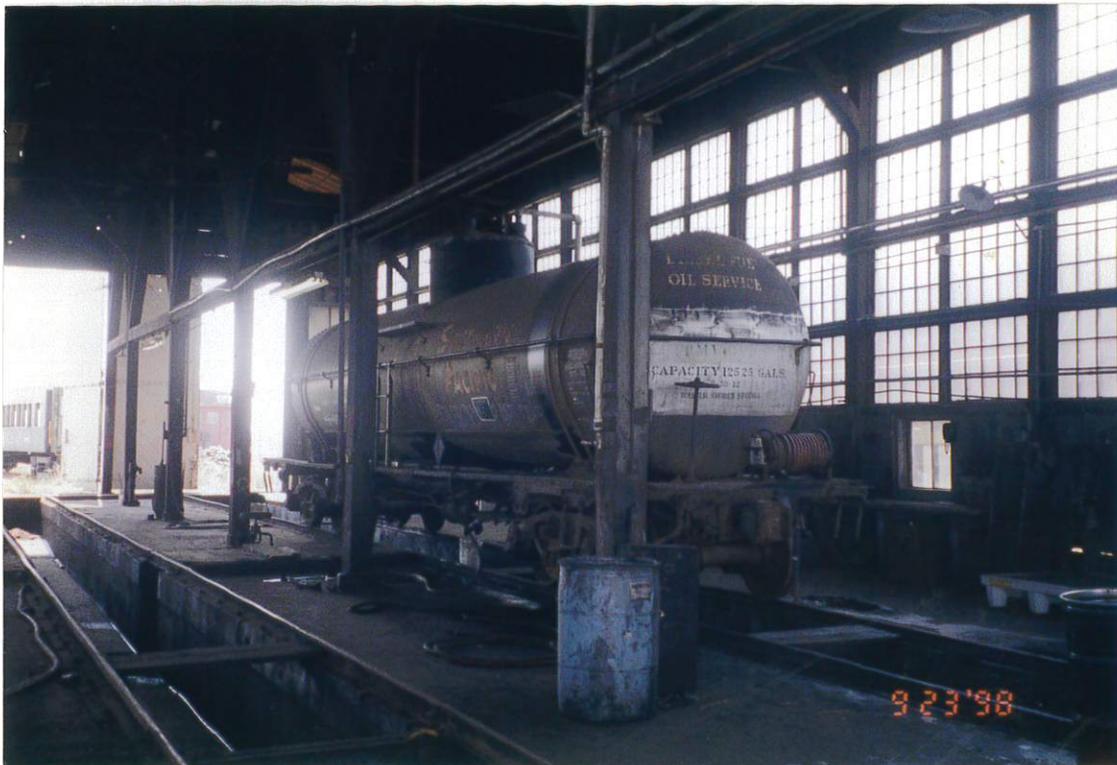
2. Railcar inside of the "roundhouse" used to store used/recycled oil. Lower right-hand corner of photo shows open unlabeled drum of oily sludge cleaned from the trench.

Stored on the tracks over this trench is a railcar used for the storage of recycled oil (Attachment A, photo #2) that will be burned in locomotive #45 (steam engine). Mr. Rexrode stated that when this current load of recycled oil arrived it had a strong smell to it. Mr. Rexrode attributed the odor to the higher atmospheric temperature at the time of its arrival. Mr. Milliman assured me that only engine #45 (steam engine) burns the recycled oil and that the Skunk Train started purchasing the recycled oil in February or March 1998. I asked Mr. Milliman how long Ms. Hakin had been the supervisor of the roundhouse. Mr. Milliman stated that Ms. Hakin had supervised the maintenance operations from August 1996 to January 1998 at which time another, unnamed individual, was hired to oversee the maintenance operations. The original stenciling on the side of the railcar had been marked out and the word "DISMANTLE" stenciled on to the railcar (Attachment A, photo #3). A 5-gallon bucket was hanging from a valve (Attachment A, photo #4) on the underside of the railcar. Mr. Rexrode explained that #45 had been fueled from this car earlier this morning and the bucket was used to collect drippings from the valve. I asked for permission to sample the oil in the bucket (1/2 full) and both Mr. Milliman and Mr. Rexrode granted me permission.

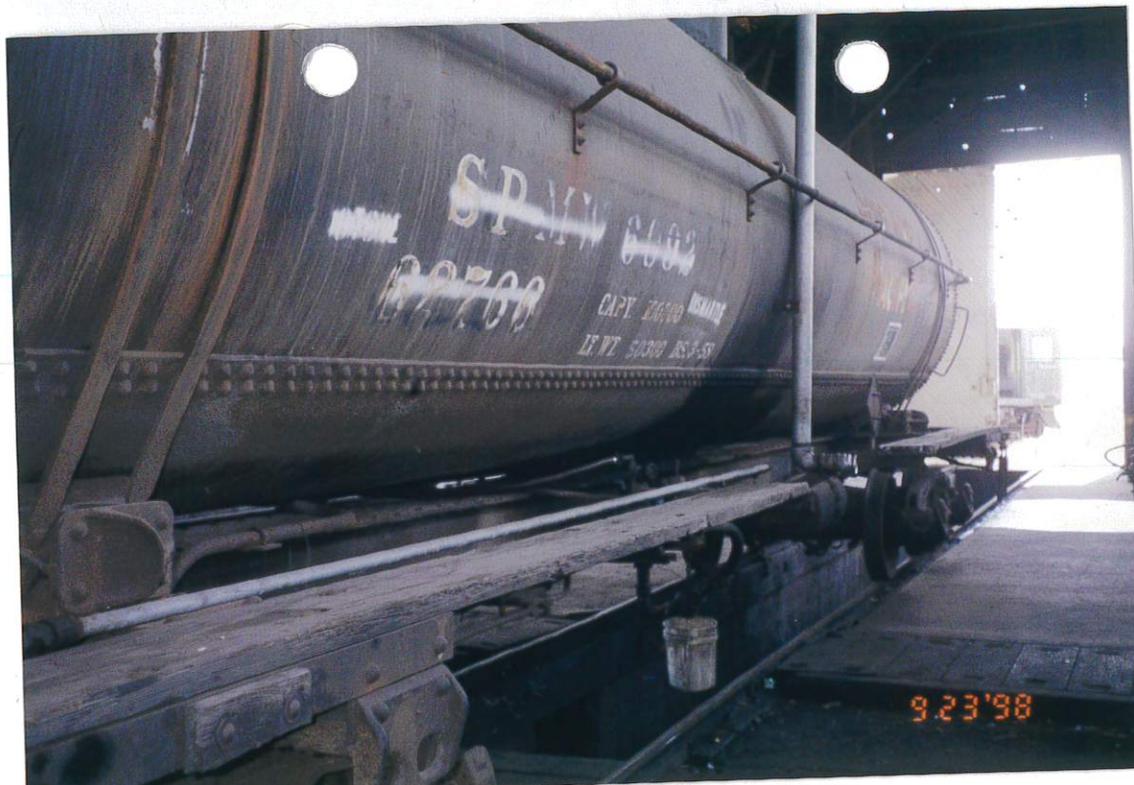
3. Other side of railcar in photo #2. The word "Dismantle" is stenciled on the side of the railcar. Note the bucket underneath the car.

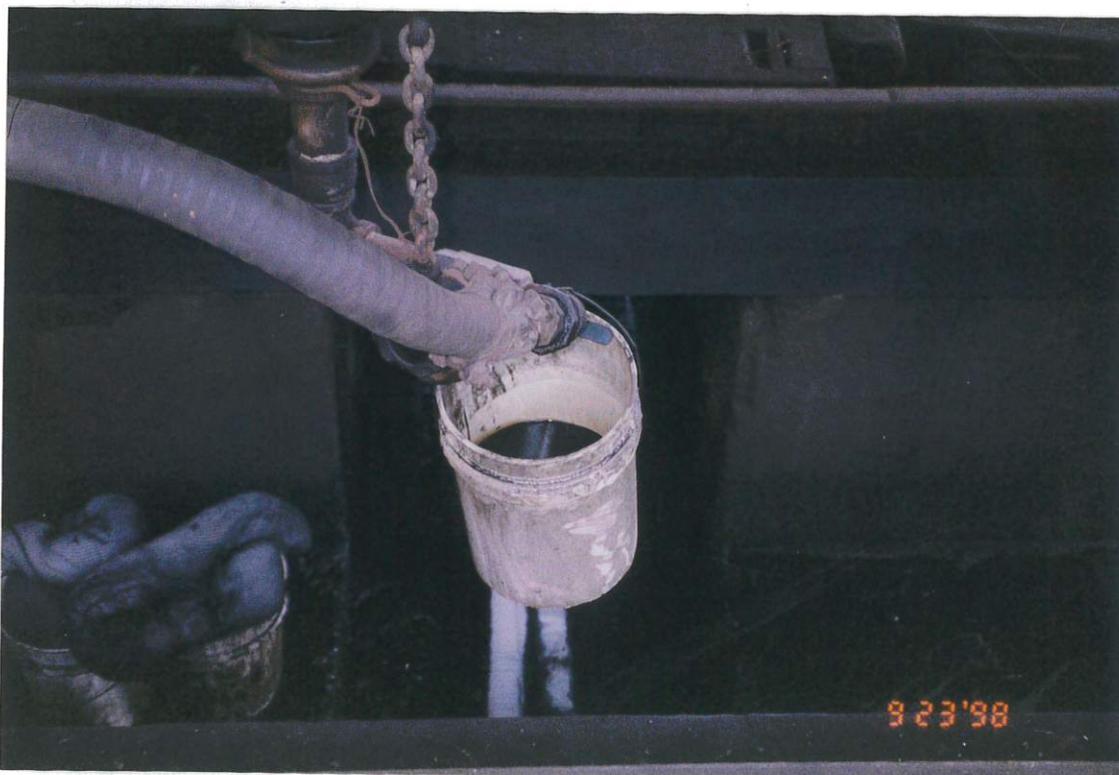
4. Close-up of the bucket in photo #3. Used to collect leaking oil from the railcar valve.

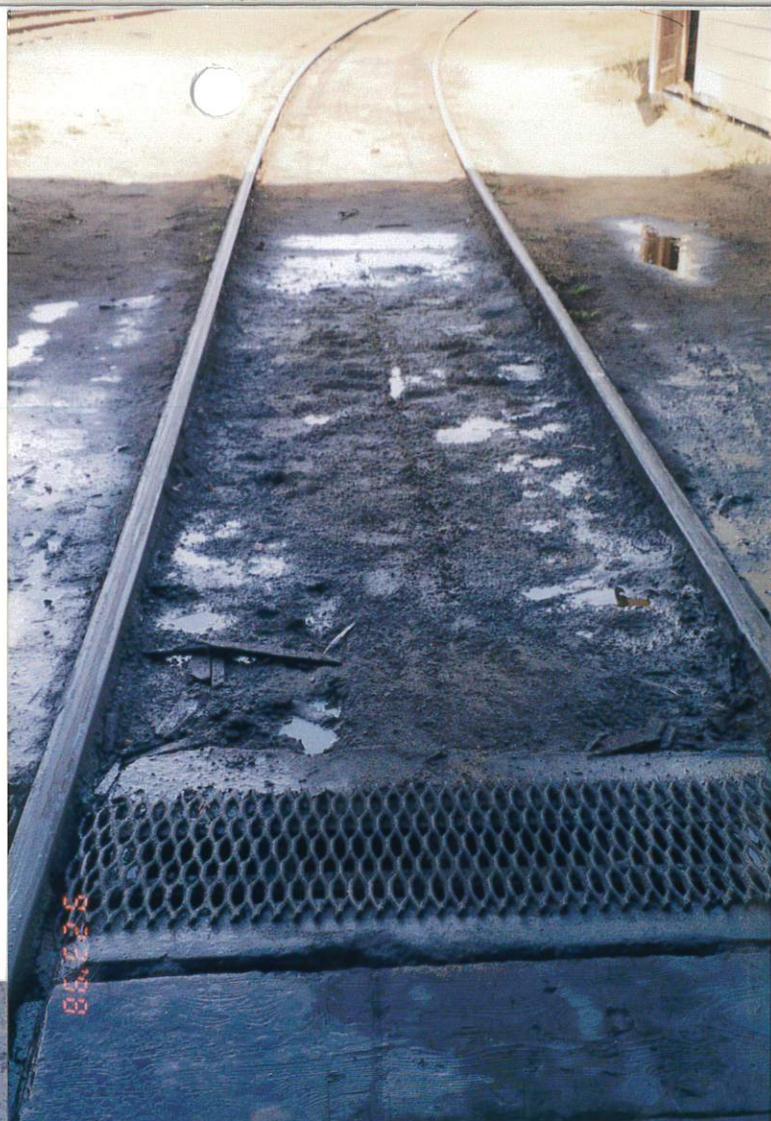
5. Oil soaked soil around the rail tracks leading to the railcar in photo #2.

As we exited the roundhouse to the north I noted an area of soil between the tracks that had standing liquid in it and appeared to be saturated with oil (Attachment A, photos #5-6). Mr. Milliman explained that locomotive #45 is positioned here when it fills up with the oil from the railcar. The oil on the soil is from leakage that occurs from the locomotive. I then collected a sample of the oil in the 5-gallon bucket under the railcar. As I exited the roundhouse to the north again I observed a mound of black sand-like material located on the soil between the two sets of tracks (Attachment A, photos #9-12). Next to the sand-like material was a separate pile of oily soil. Upon questioning Mr. Rexrode I learned that a bin of ash from the steam engine (#45) had been dumped here recently. Mr. Rexrode stated that the oily soil had probably fallen off of the tracks of the tractor used to move the bin. I asked Mr. Milliman and Mr. Rexrode if a hazardous waste determination had been made on this waste. Mr. Milliman said that no determination had been made and was unaware that such a determination would be required. Mr. Rexrode explained that this was not the normal area for dumping the ash from the steam engine. According to Mr. Rexrode, the ash is usually dumped at the south end of the roundhouse. I told Mr. Milliman that I would like to sample the soil at this location and the soil at the south end of the building and have the samples analyzed. Mr. Milliman did not object and went back to his office while I collected a sample of the black sand-like material. While collecting the sample I noted a plastic bag partially full of green colored grease buried in the sand-like material.

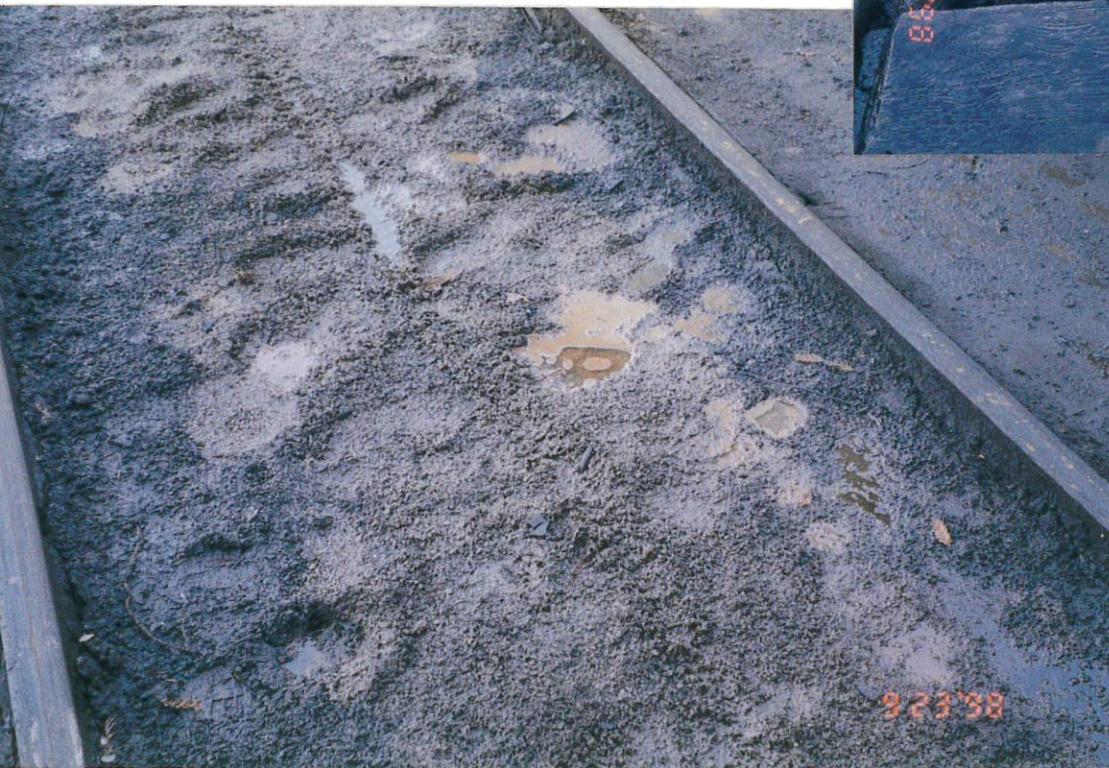
6. Close-up of soil in photo #5. Allegedly due to leakage during start-up and fueling of the steam engine (locomotive #45).

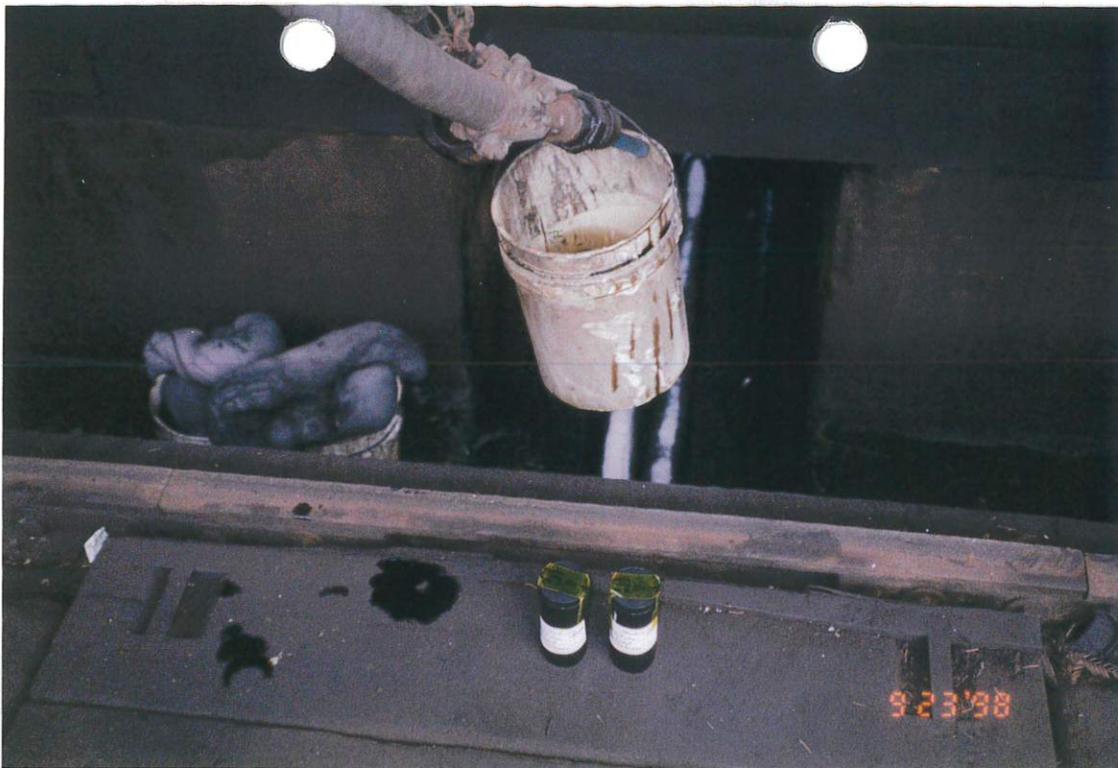
7. Sample Skunk-01 collected from the white plastic bucket of oil.

Sample Skunk-01: This sample was collected from the 5-gallon bucket of oil hanging from the valve on the underside of the railcar in the roundhouse (Attachment A, photos #7-8). After putting on my personal protective equipment (PPE) I used a new (clean and unused) 8oz sampling jar to scoop the oil from the bucket and pour it into the sample containers. Since Mr. Milliman was not initially present when I started the sample collection I collected two split samples. When Mr. Milliman arrived I asked him if he wanted one of the samples and he declined. Analysis of the sample showed that it met the recycled oil specifications in its certification (Attachment D) and would not be considered a hazardous waste.

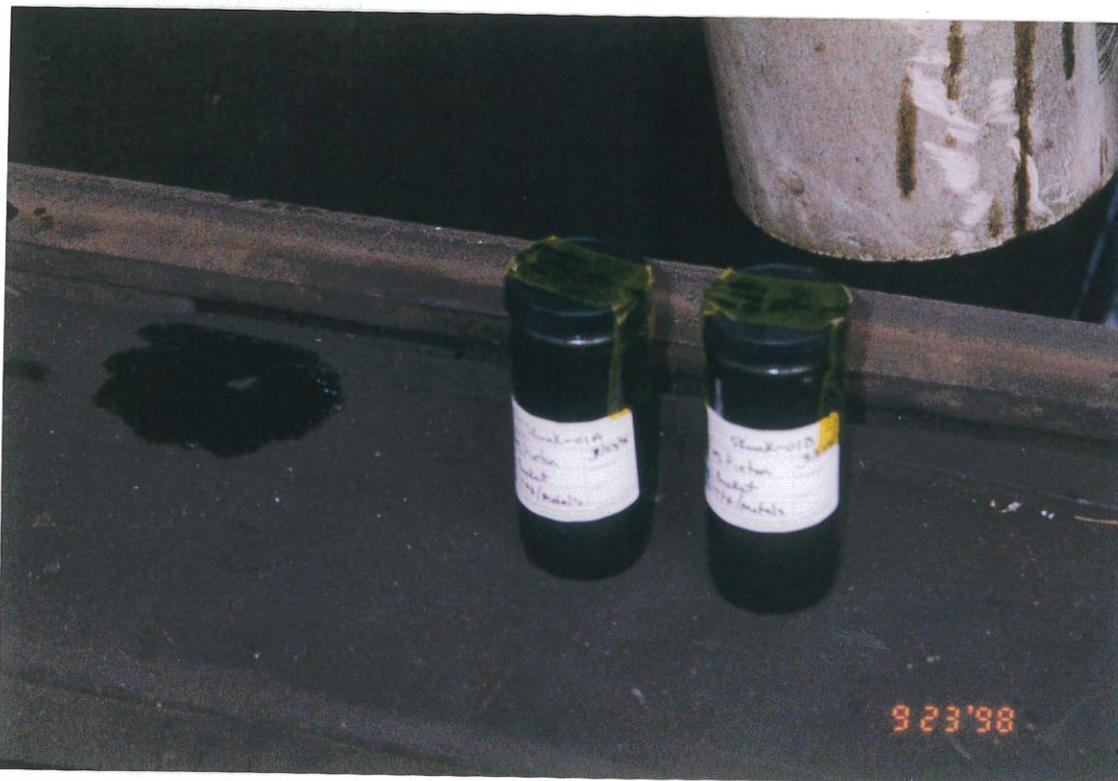
8. Close-up of sample Skunk-01.

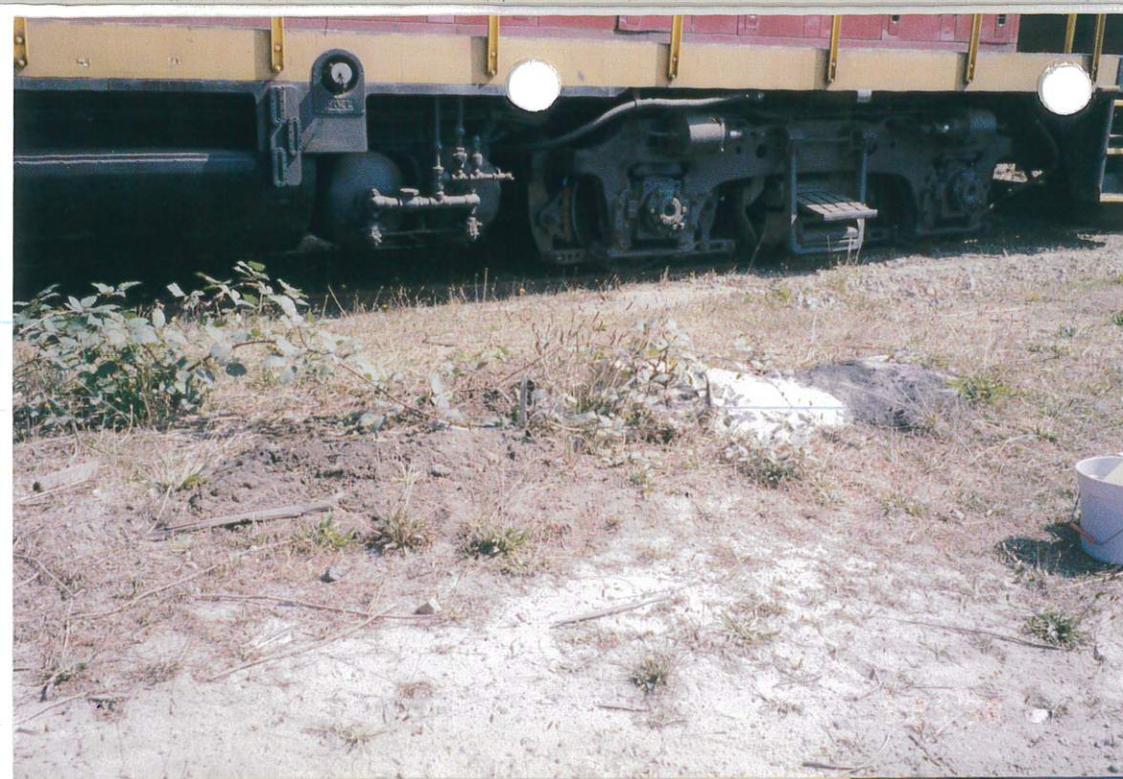
9. Area of contaminated soil to the north of the "roundhouse".

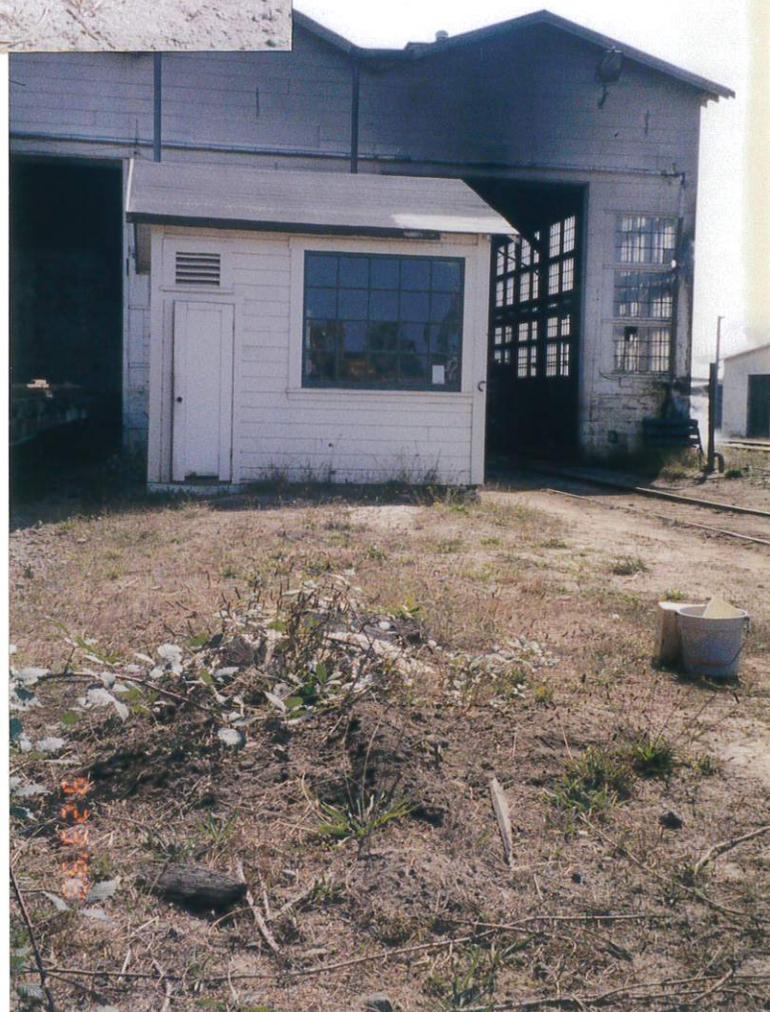
10. Overview showing position of the contamination in photo #9 to the "roundhouse". No fence or gate to block public access.

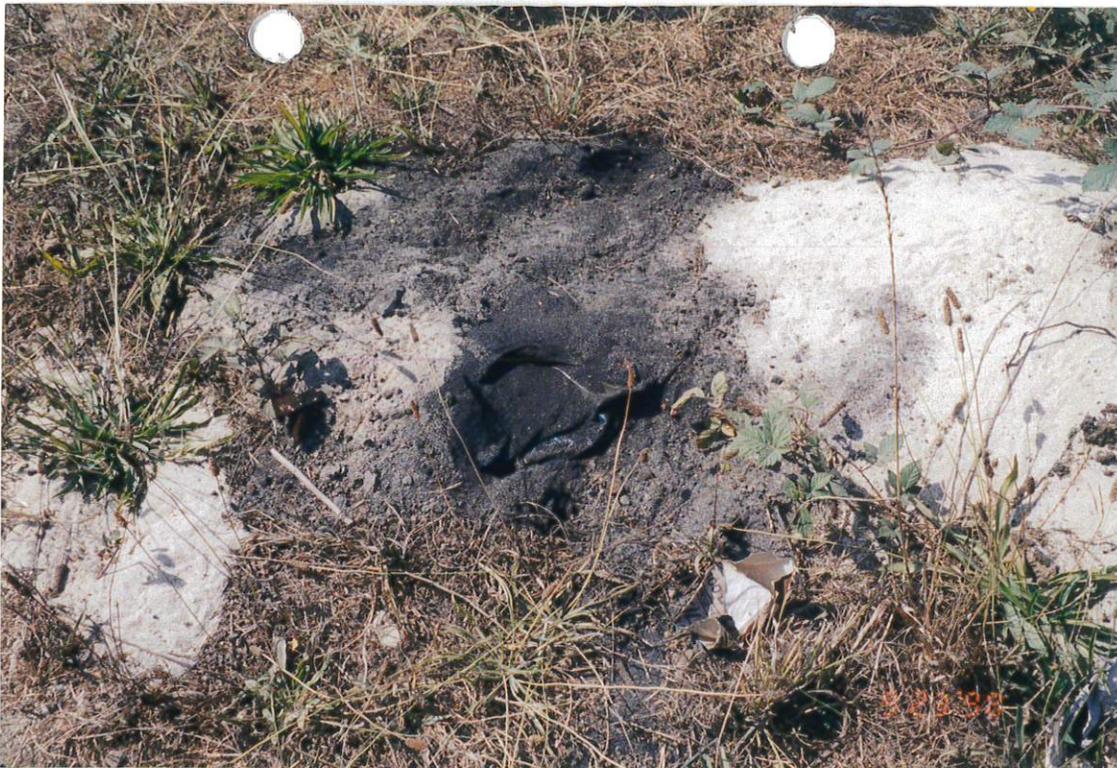
11. Close-up of the black sand-like waste on the ground in photo #9. Alleged to be firebox ash from the locomotives.

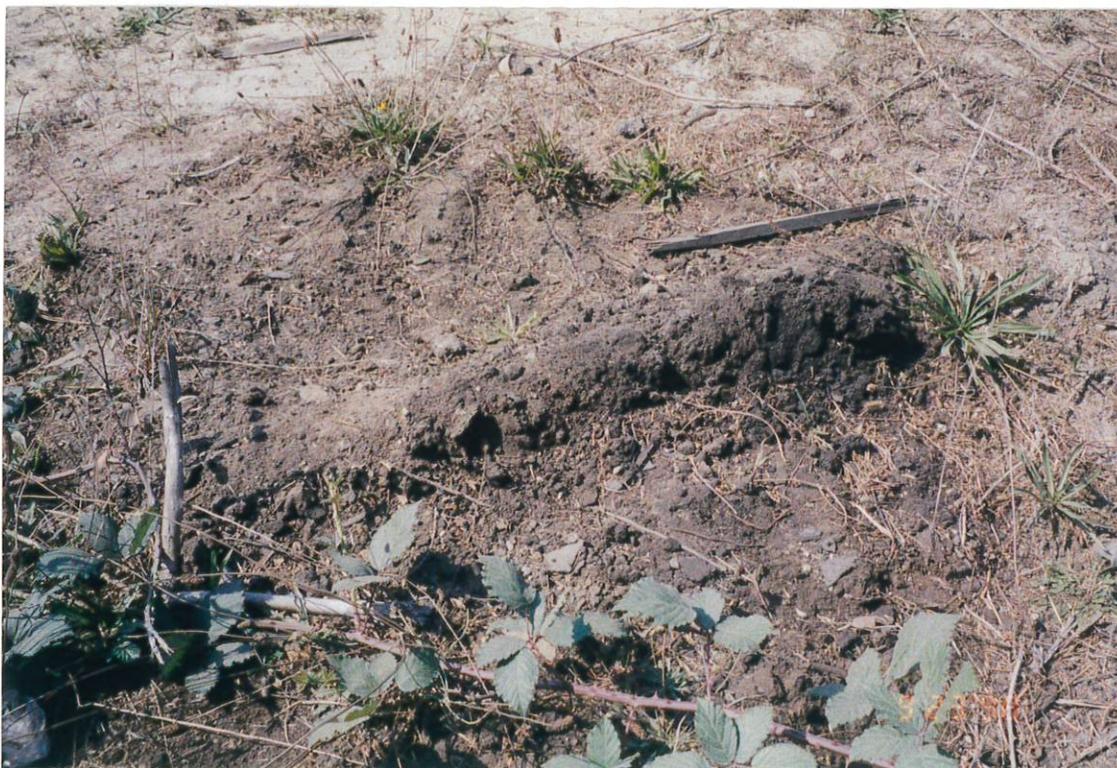
12. Close-up of the potentially oil-contaminated soil in photo #9. Alleged to have fallen off of the tractor used in this area.

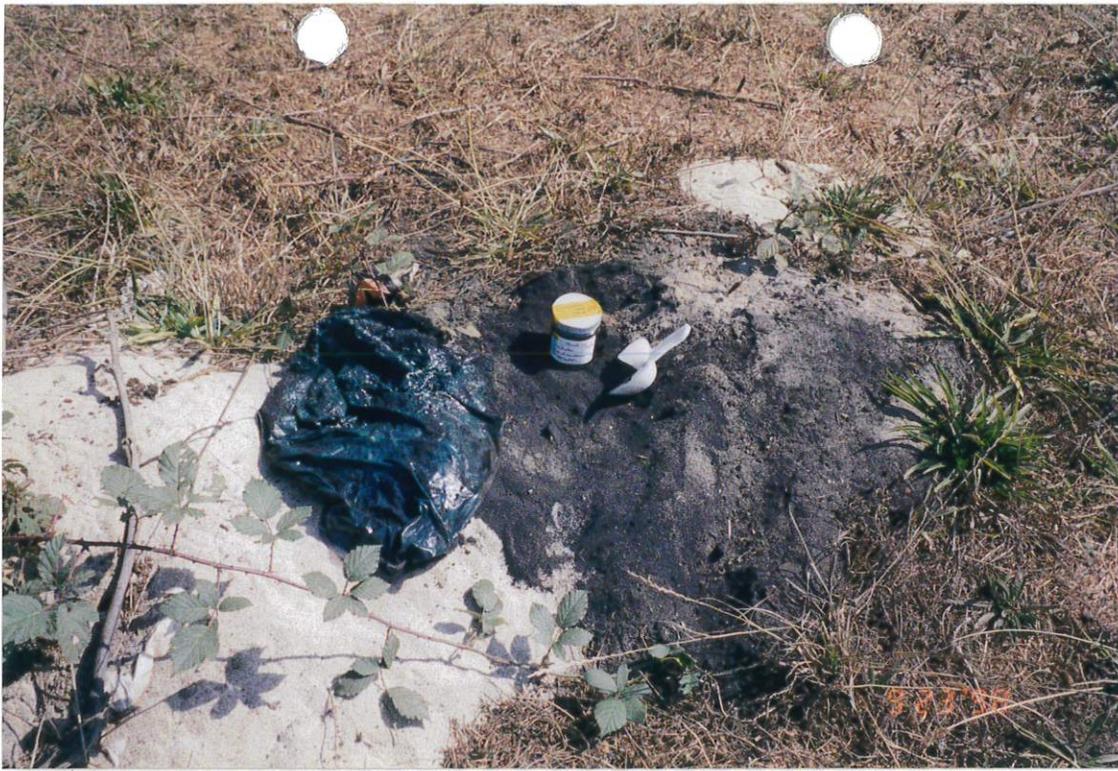
13. Sample Skunk-02 and a plastic bag of grease removed from the pile.

Sample Skunk-02: This sample was collected from the pile of black sand-like material at the north end of the roundhouse (Attachment A, photos #13-14). After putting on new gloves, I used a new plastic scoop to collect the sample. I filled an 8oz new glass jar with the material. After collecting the sample I used the trowel to pull the plastic bag of grease out of the pile and open it up to verify its contents (Attachment A, photo #15). Analysis of the sample showed that it was hazardous for total and soluble zinc, soluble lead, and soluble copper. This sample constitutes a hazardous waste disposed of to the soil.

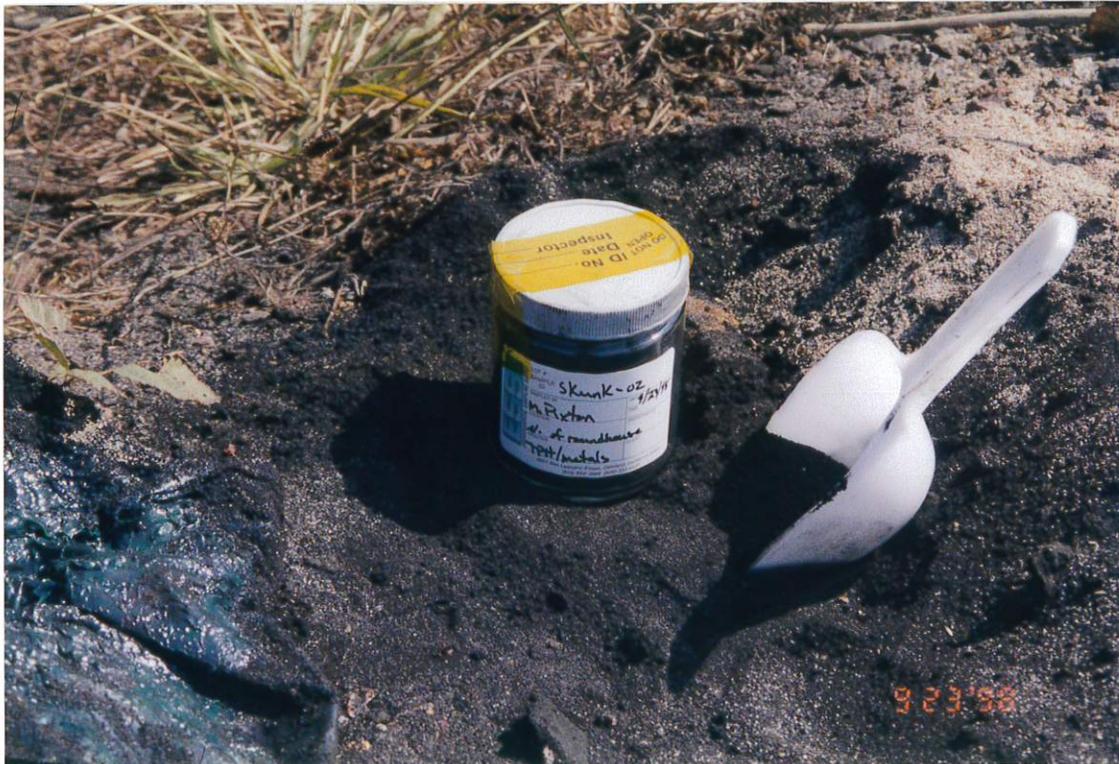
14. Close-up of sample Skunk-02.

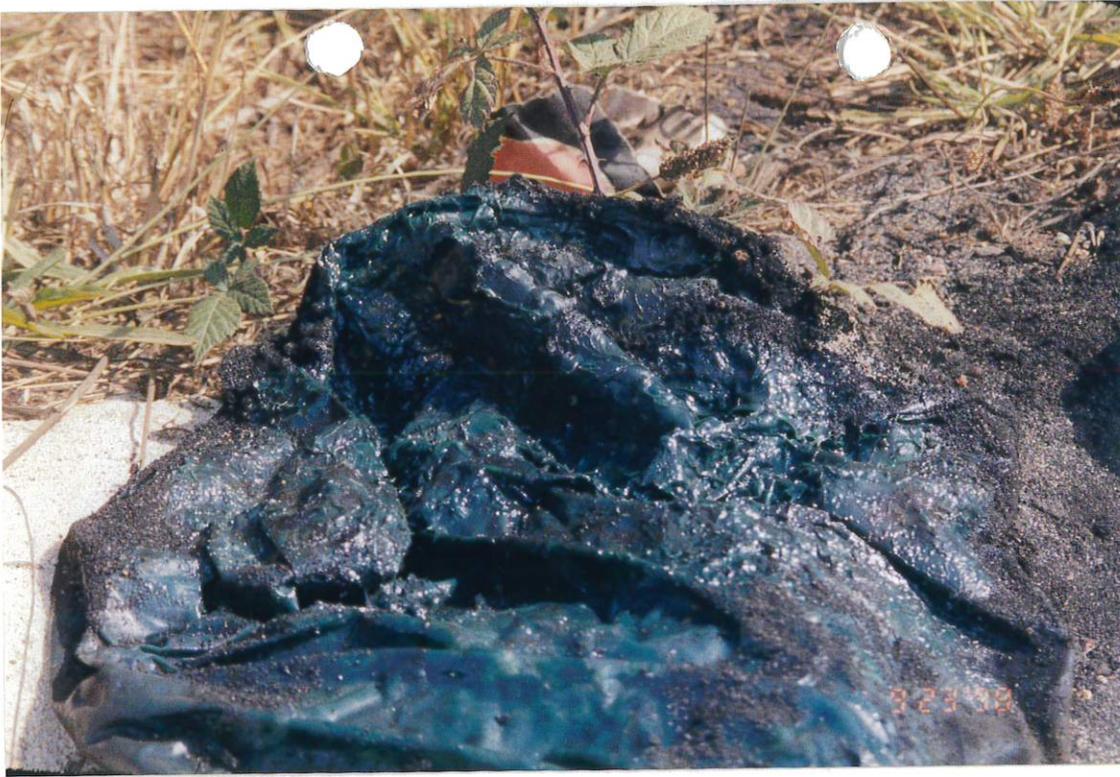
15. Close-up of the grease in the bag next to sample Skunk-02.

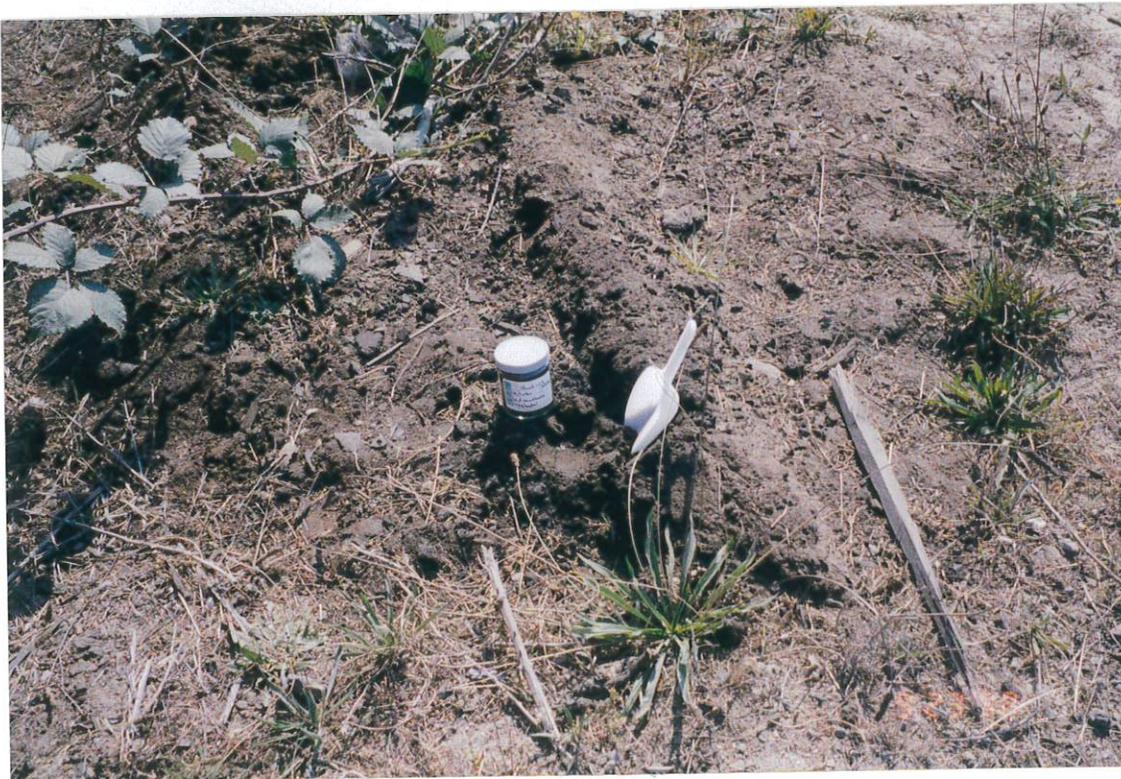
16. Sample Skunk-03.

Sample Skunk-03: This sample was collected from the pile of oily soil at the north end of the roundhouse (Attachment A, photos #16-17). After putting on new gloves, I used a new plastic scoop to collect the sample. I filled an 8oz new glass jar with the material. Analysis of this sample showed that it was hazardous for soluble lead and waste oil. This sample constitutes a hazardous waste disposed of to the soil.

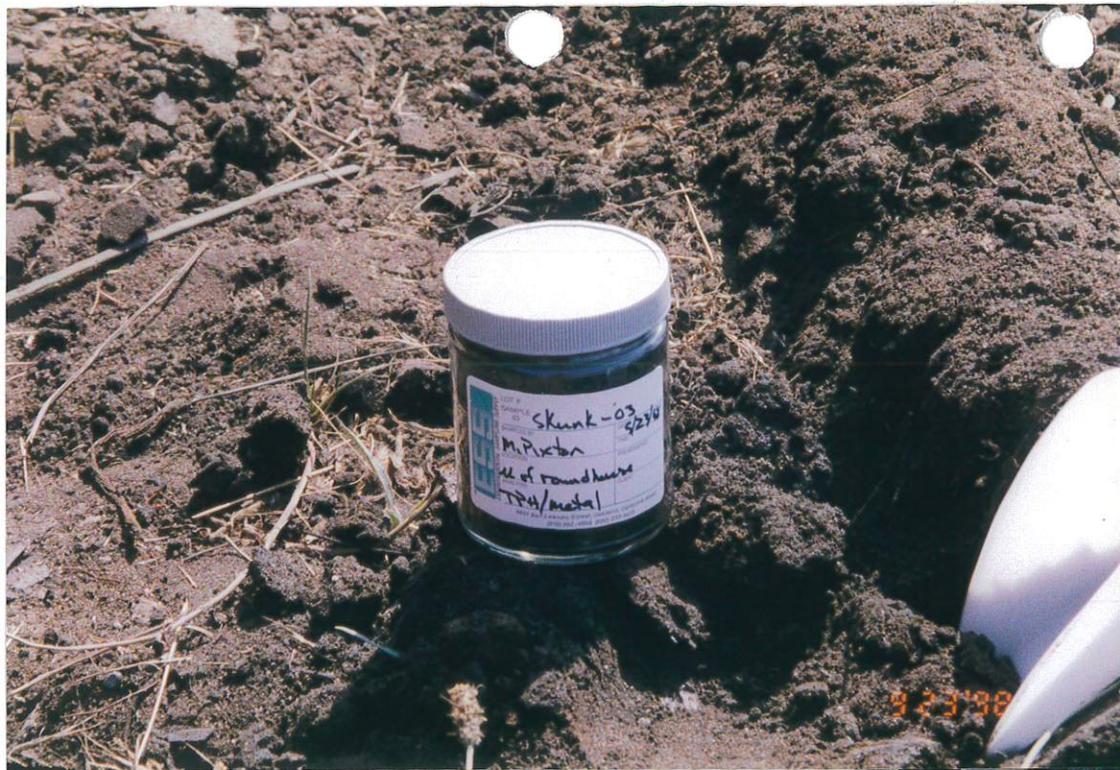
17. Close-up of Skunk-03.

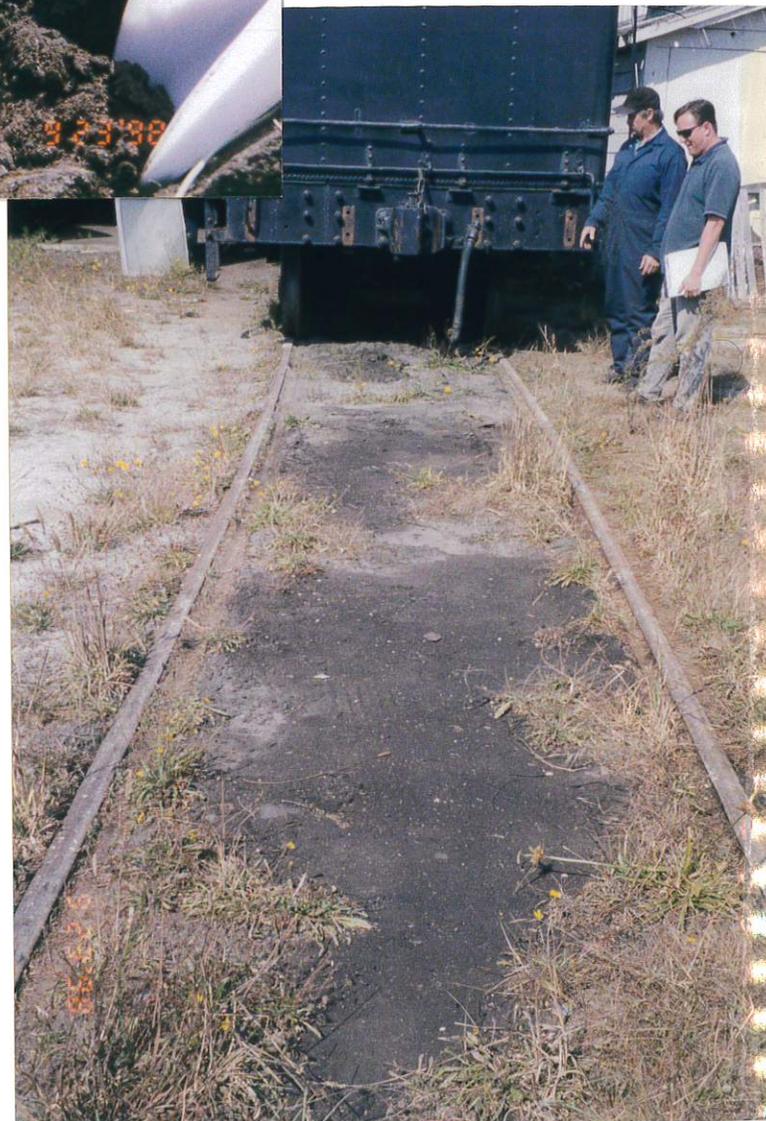
Sample Skunk-04: This sample was collected from the soil between the eastern set of tracks at the south end of the roundhouse (Attachment A, photos #18-20). After putting on new gloves, I used a new plastic scoop to collect the sample. I filled an 8oz new glass jar with the material. Analysis of this sample showed that it was hazardous for soluble lead and waste oil. This sample constitutes a hazardous waste disposed of to the soil.

18. South end of rail tracks that pass through the "roundhouse". Note the darkly stained soil.

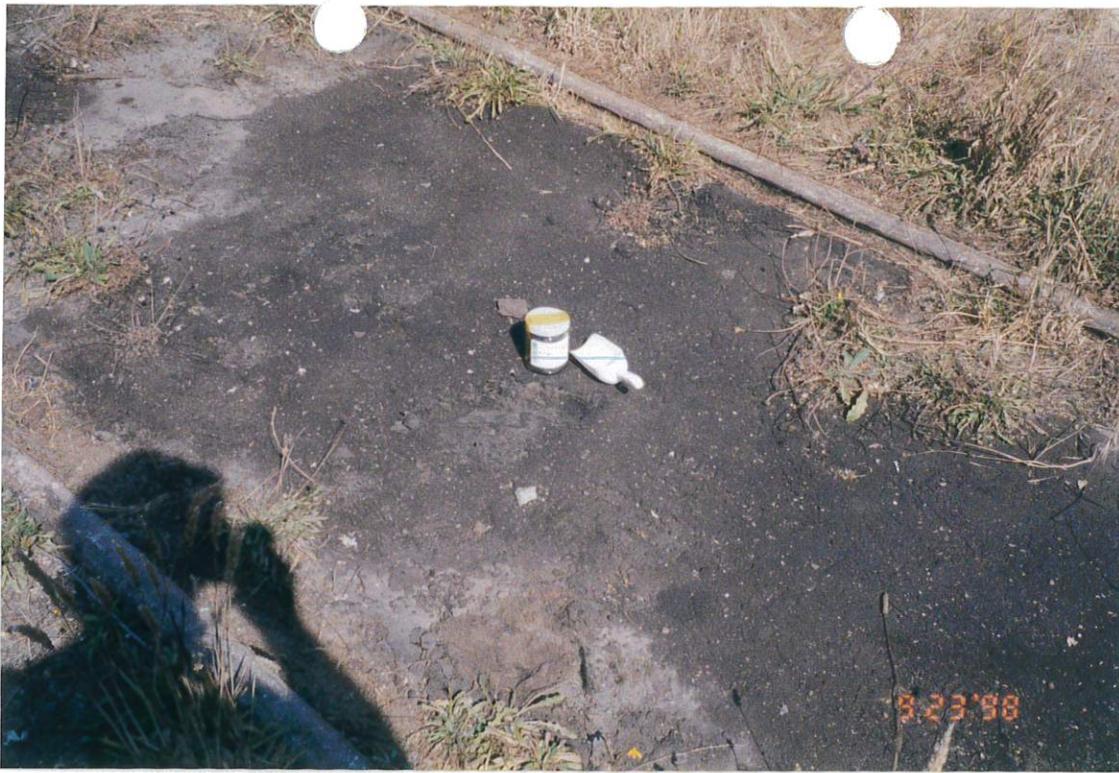
19. Sample Skunk-04 taken from between the tracks in photo #18.

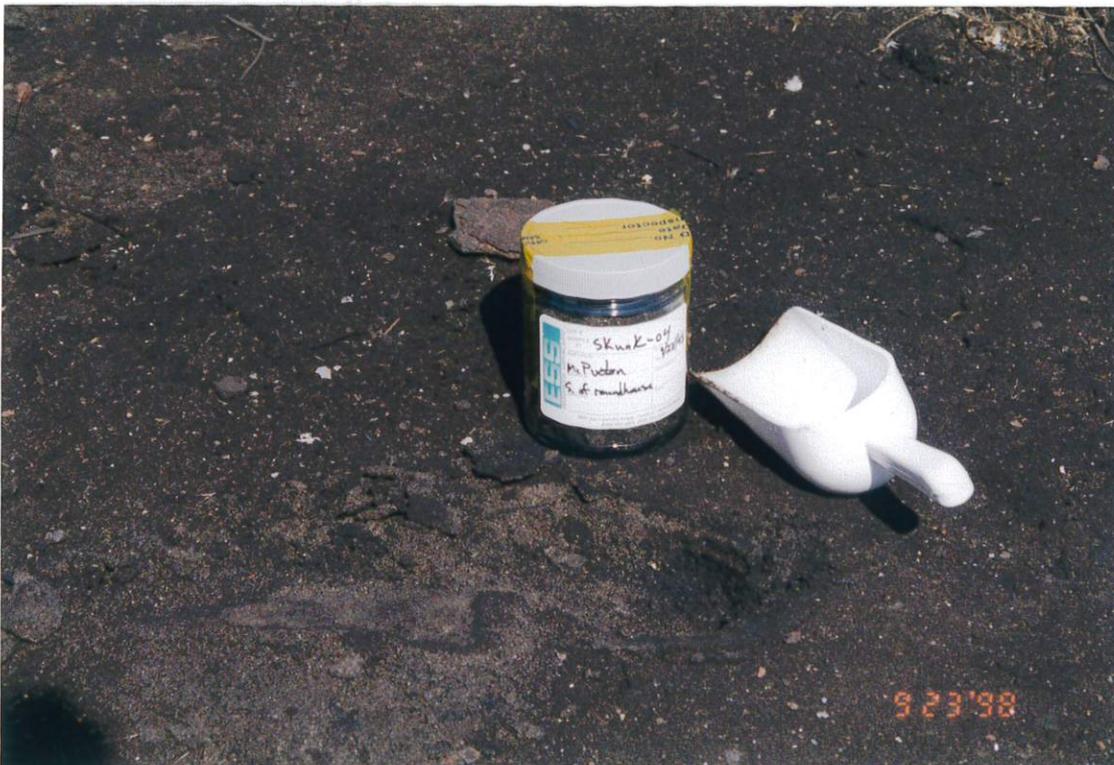
20. Close-up of sample Skunk-04.

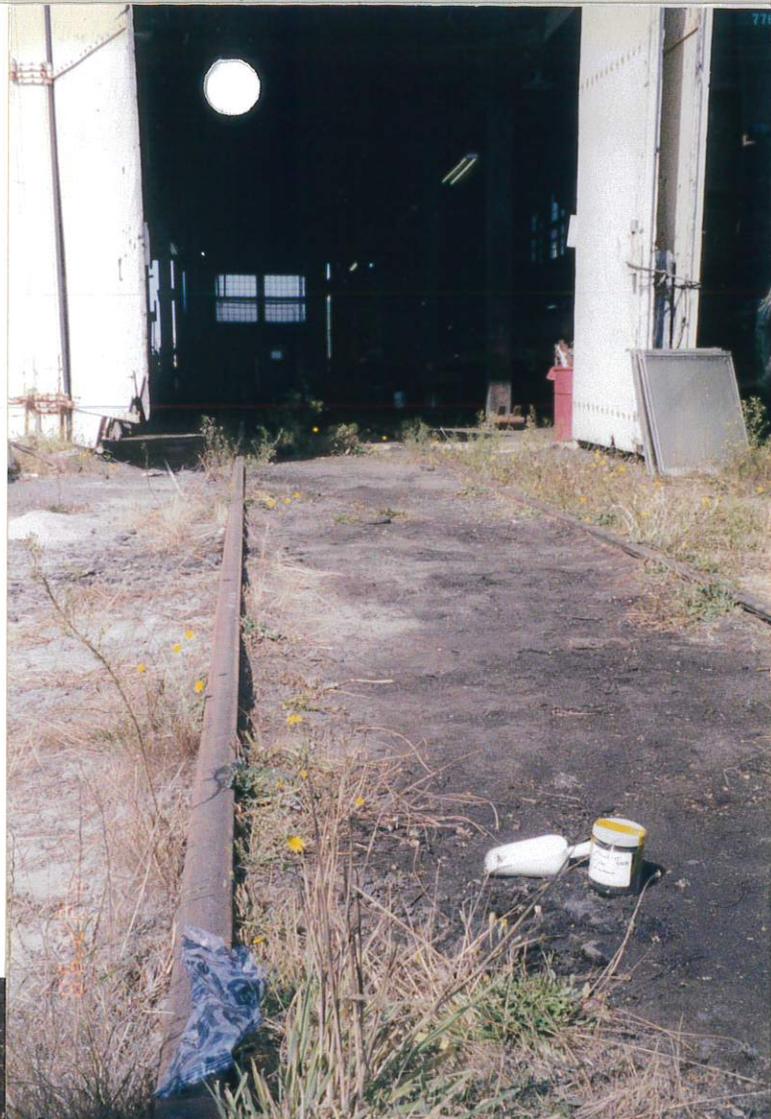
Sample Skunk-05: This sample was collected from the soil between the western set of tracks at the south end of the roundhouse (Attachment A, photos #21-22). After putting on new gloves, I used a new plastic scoop to collect the sample. I filled an 8oz new glass jar with the material. Analysis of this sample showed that it was hazardous for waste oil. This sample constitutes a hazardous waste disposed of to the soil.

21. Sample Skunk-05 taken from second set of rail tracks parallel to those in photo #18.

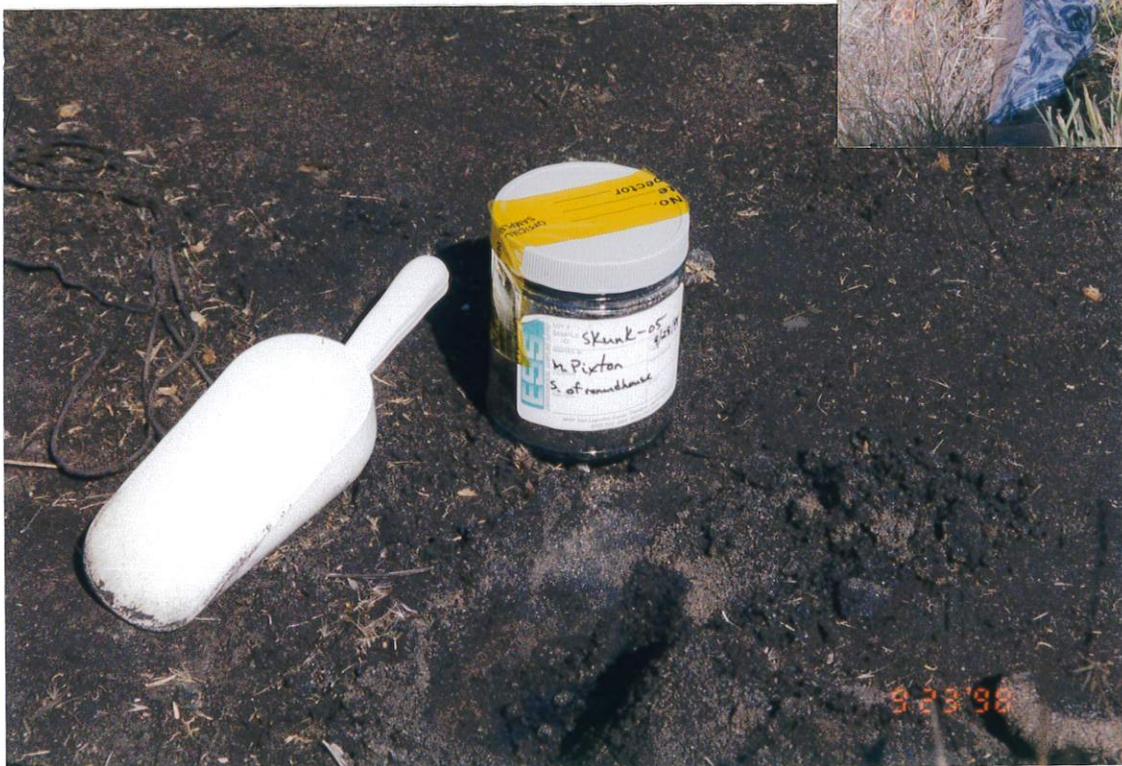
22. Close-up of sample Skunk-05.

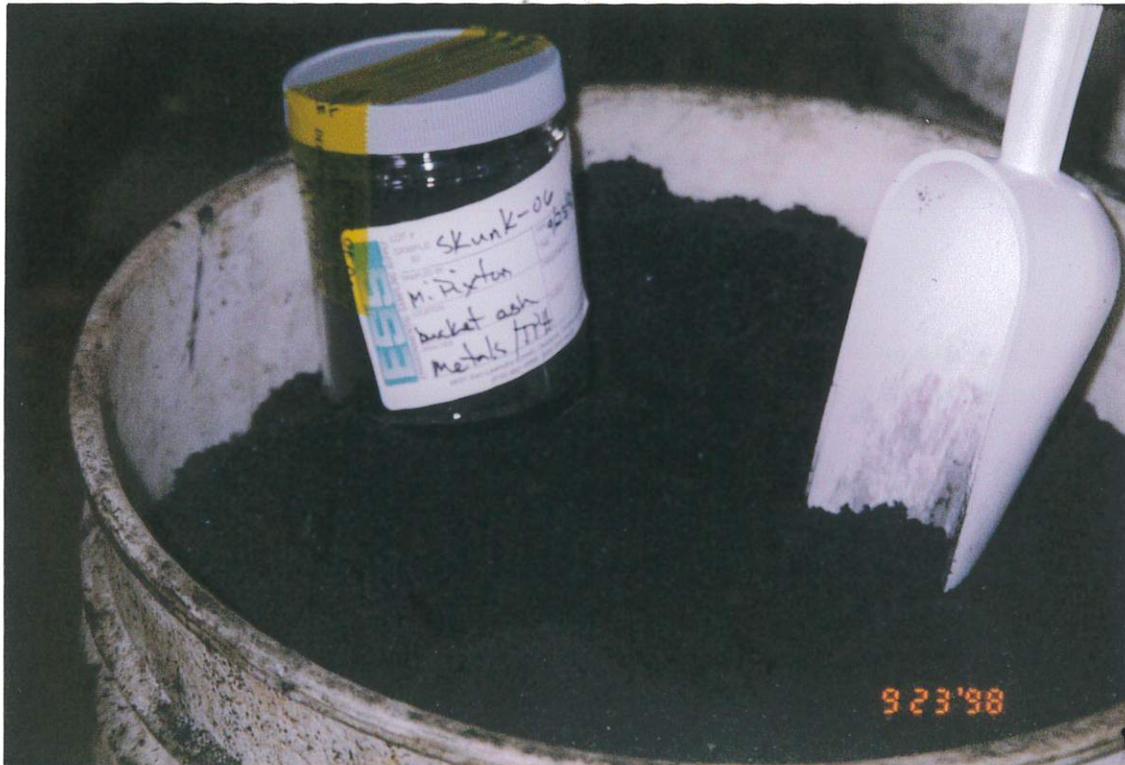
Sample Skunk-06: This sample was collected from the 5-gallon bucket of fresh ash (Attachment A, photo #23) sitting on the floor of the roundhouse (base of stairs leading to offices). Mr. Rexrode stated that this waste was freshly generated (that morning) and they had not yet dumped it. Mr. Rexrode assured me that he would place it in a hazardous waste container until a final decision on its management was reached. After putting on new gloves, I used a new plastic scoop to collect the sample. I filled an 8oz new glass jar with the material. Analysis of this sample showed that it was hazardous for soluble zinc. This sample constitutes a hazardous waste disposed of to the soil.

23. Sample Skunk-06 taken from a bucket of firebox ash that had not yet been disposed of to the soil. Removed from the firebox earlier on this date.
