INVESTIGATION REPORT

Company Name: California Western Railroad (Skunk Train)

Date of Investigation: September 23, 1998

Investigation Report
California Western Railroad – Skunk Train
September 23, 1998

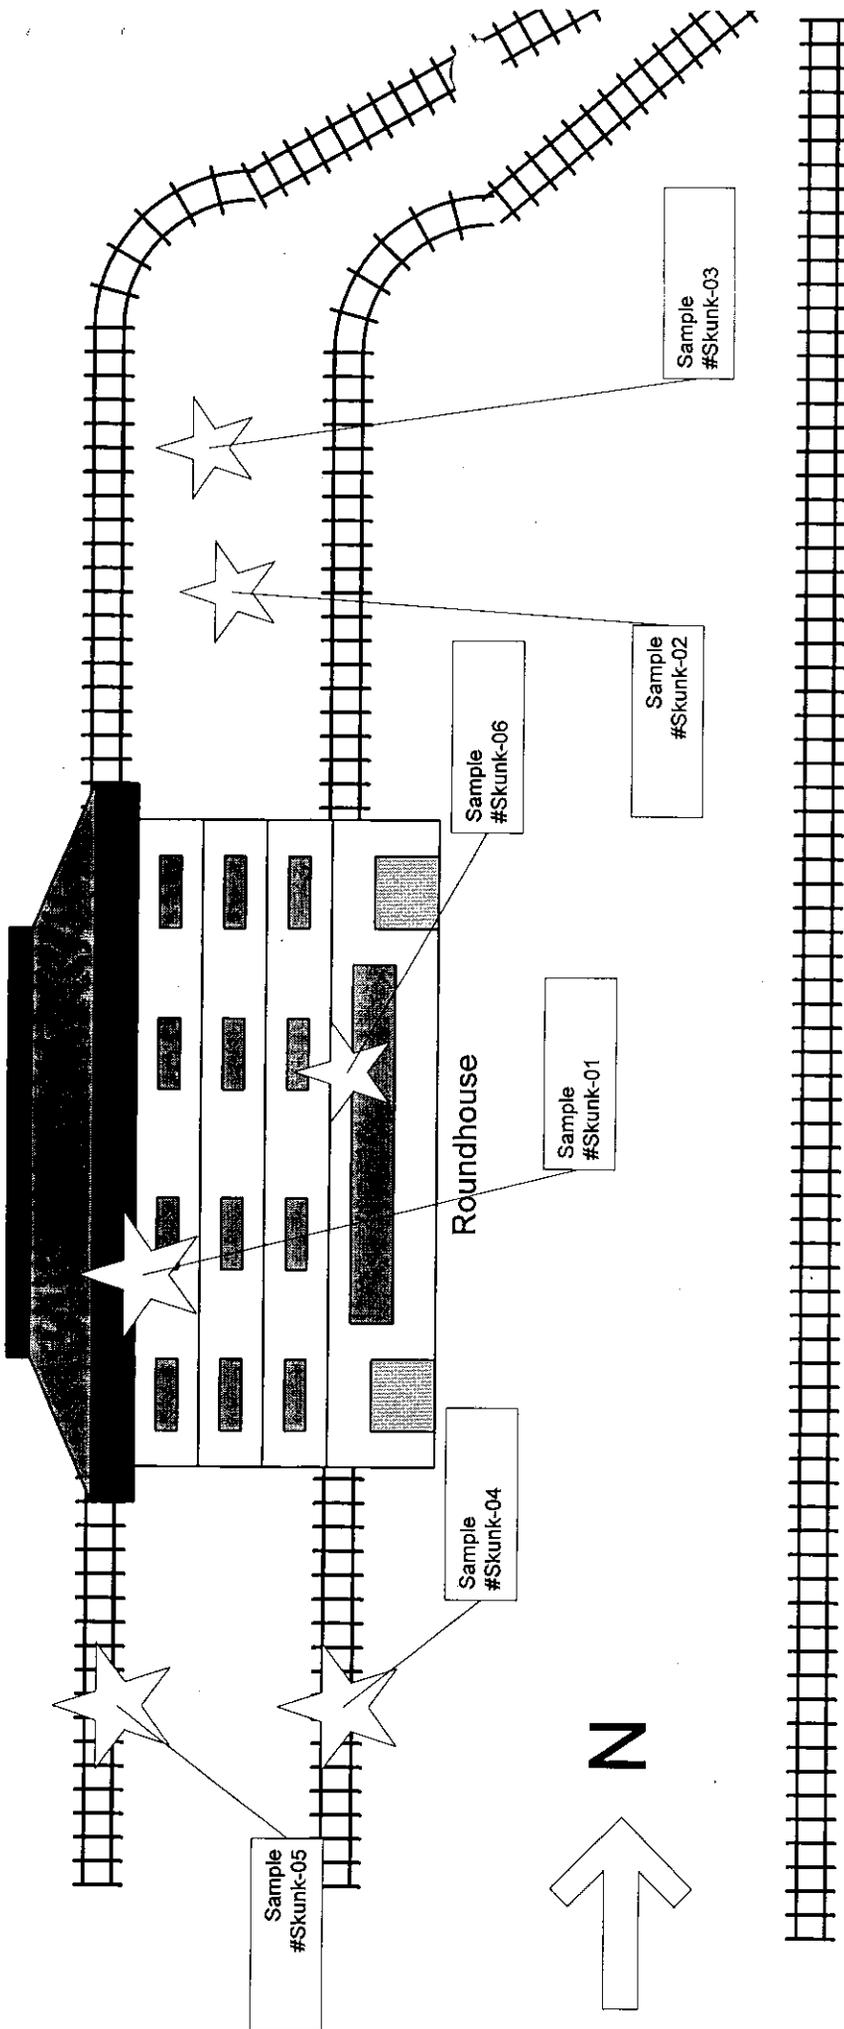
California Western Railroad (Skunk Train)
 100 E. Laural Street, Fort Bragg
 (Not to Scale)

Facility Map with sample location
